MICROPILES | TIEBACKS | SOIL NAILING

BATTLE MOUNTAIN SLIDER REPAIR - MINTURN, COLORADO

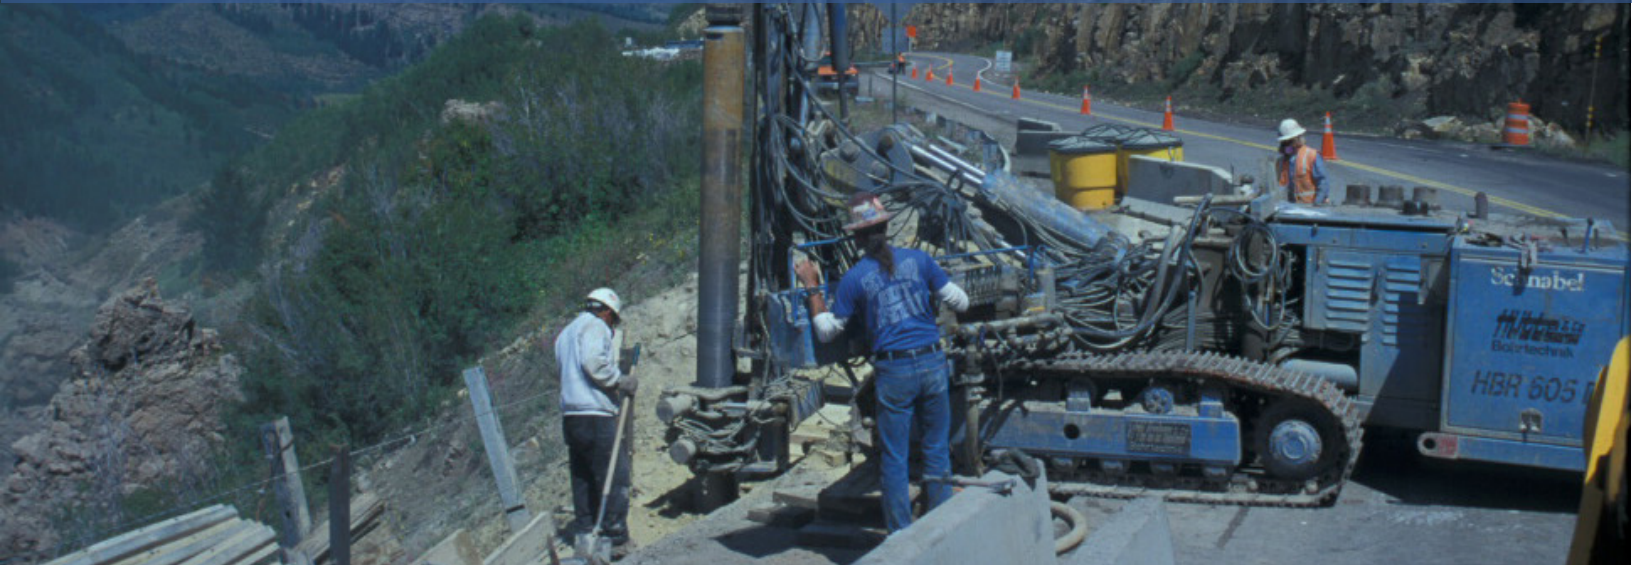
The design for the slide repair contemplated not only a fix for the current roadway alignment, but through the use of a tiedback/micropile supported cap beam, the ability in the future to add another highway lane that would cantilever out from and over the cap beam. The project required about three months to complete and included the installation of (1) 37 – 10 inch diameter micropiles; (2) 18 – 6 strand tieback anchors; (3) 1,000 SF of temporary soil nail shoring for the cap beam cut; and (4) 1,500 LF of horizontal drain drilled into the mountain along the uphill side of the road.
